DEPARTMENT OF TRANSPORTATION**DIVISION OF ENGINEERING SERVICES**

Contract #: 04-0120F4Cty: SF/ALA Rte: 80 PM: 13.2/13.9File #: 69.28**WELDING INSPECTION REPORT****Resident Engineer:**Pursell, Gary**Address:** 333 Burma Road**City:** Oakland, CA 94607**Report No:** WIR-020054**Date Inspected:** 22-Mar-2010**Project Name:** SAS Superstructure**OSM Arrival Time:** 700**Prime Contractor:** American Bridge/Fluor Enterprises, a JV**OSM Departure Time:** 1900**Contractor:** Zhenhua Port Machinery Company, Ltd (ZPMC), Changxing Island **Location:** Shanghai, China

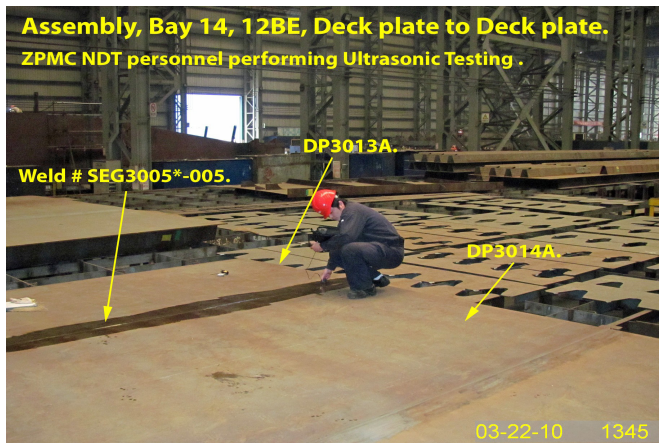
Assembly, Bay 14, 12BE, DP3013A TO DP3014A.

During the Quality Assurance (QA) random in-process visual inspection, this QA inspector observed ZPMC Personnel performing Ultrasonic Testing (UT) of Deck plannel to Deck plannel weld Identified as SEG3005*-002. The attached photographs provide additional detail.
